# K E R M A

2010-2011

SOUDAN

Matthieu Honegger • Charles Bonnet

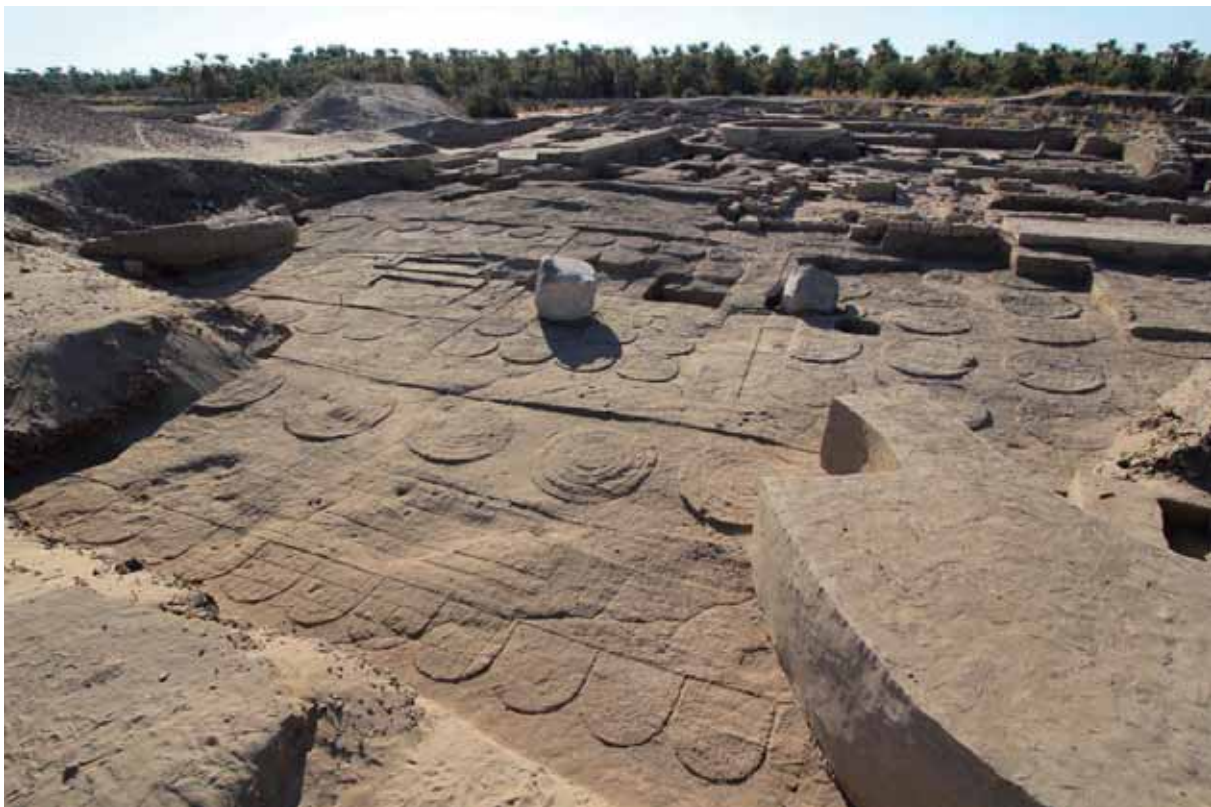
Figure 20 | General view of the remains of the eastern temple

Since we had already identified the Meroitic, Napatan, Ramesside and Amarnian phases, we didn't expect to discover an earlier state in the area of the sanctuary, since the latter had been partially invaded by a Nubian defensive line, as we found out last year. This season, we were very surprised to notice traces of orthogonal structures in places which had been cleared by the eolian erosion. These traces can be seen about 20 cm under the Nubian fortifications. We concentrated our work on this level, which could be related to the works commissioned by Thutmose I. The structures uncovered represent the southern half of the plan of a first temple built in mud brick, consisting in a tripartite sanctuary preceded by a hypostyle hall and surrounded by a peripteral portico. Ahead of the hall were found layers of sandstone fragments and negative imprints of columns, indicating that other elements dating back to the reigns of Thutmose I, Thutmose II or Hatshepsut are yet to be discovered.

The entrance axis towards the sanctuary was underlined by a brick-paved avenue showing a slight angle. The hypostyle hall comprised six rows of four columns, the foundations of which, made of mud brick, reach deep into the ground. Their proximity implies a much smaller diameter in the upper parts. Many post holes seen in the soil heaps of this level pertain to strengthening works carried out during the building process. The regular series of very small holes, with a diameter of 1.5 cm, which underline the perimeter of the concentric circles forming the foundations, may have been used as construction markers. They are found in very large amounts.

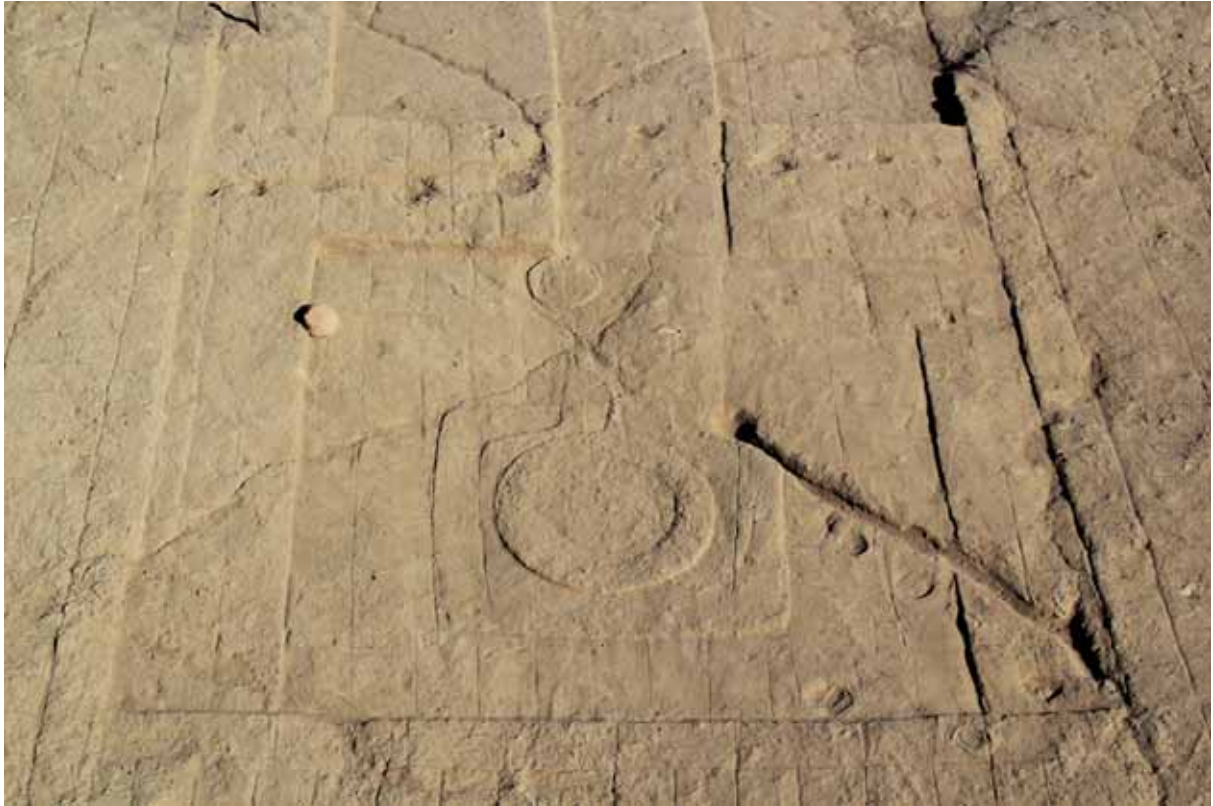
Figure 21 | The sanctuary of the eastern temple.

The central aisle would lead to a vestibule used as antechamber ; a thick wall would separate it from the holy of holies, which measures 2.75 m by less than 2 m. Wall benches were found on three sides. On the main axis, four steps would reach a quadrangular base with rounded angles, which was covered by a thick coating of silt, as were the lateral sides of the stairs. On this slightly decentred base was built a circular foundation, with a diameter of 90 cm. Made of several concentric mud rings, it was probably meant to support the base of an altar or a naos. In front of the entrance door, to the west, is found another mud foundation, with a diameter of 30 cm, which is probably related to the presence of a vessel.

All these developments were also found on the floor, as if drawn by double rows of very small circular holes, probably reeds driven in the ground. In the eastern half of the sanctuary, a deep drainage channel could be followed up to the peripteral portico, which enabled the evacuation of the water used for libations. Restoration works are suggested by post holes on both sides of this channel and in the walls separating the sanctuary and the antechamber (fig. 21).

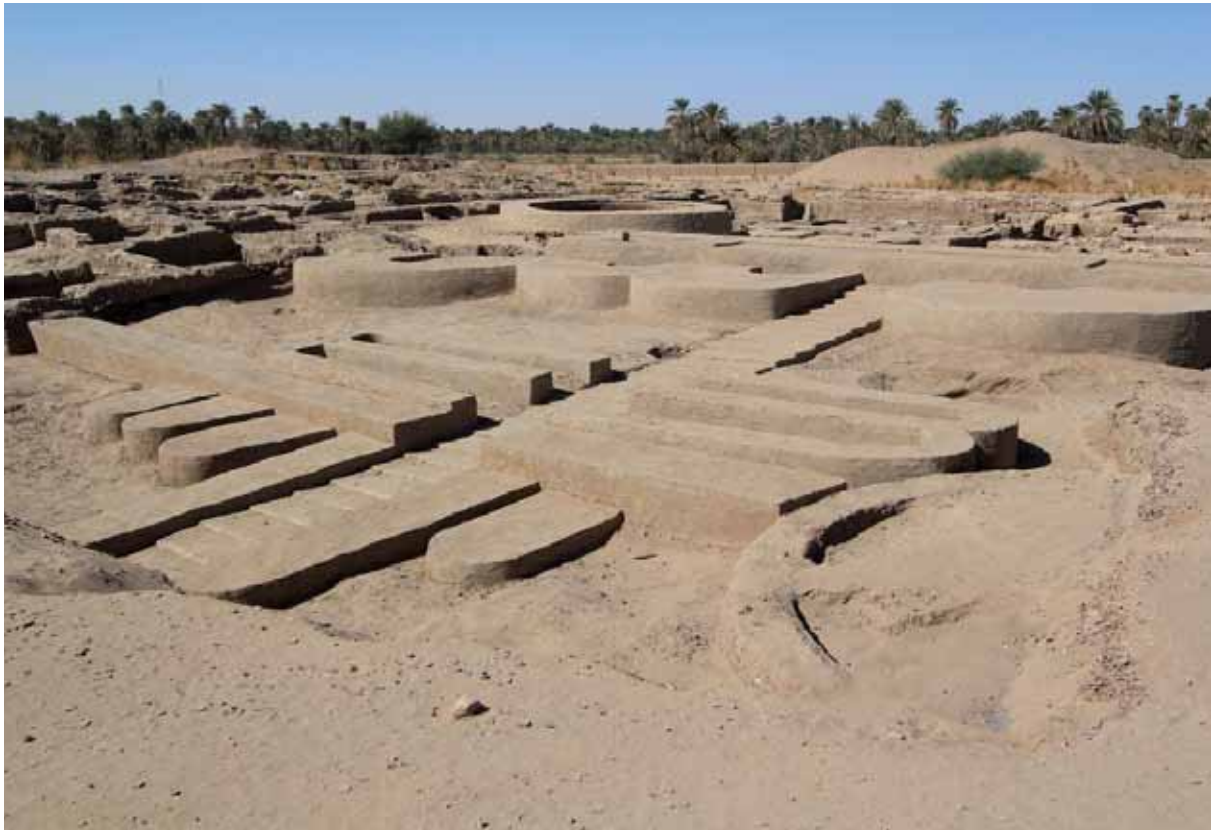
Figure 22 | Southern part of the fortifications after restorations.

In order to prepare the restoration works and the enhancement of the remains of the southern part of the Egyptian town, the excavations were continued on both sides of the staircase connecting the southern door with the central temple (fig. 22). The detailed plan of four bastions could be mapped, as the remains were in a good state of preservation. It is clear that these elements, which may have been erected at the end of the reign of Thutmose I, were enlarged and transformed several times.

Semi-circular facings, consolidated by rather large posts, strengthened the external walls. Their plan crosses narrow and transverse older bastions which protected the bottom part of the bastions. A thick wall equipped with narrow bastions pertains to one of the last modifications made, probably under the reign of Hatshepsut. We could note that this fortified line would continue for about 50 m before it would turn at a right angle towards the north.

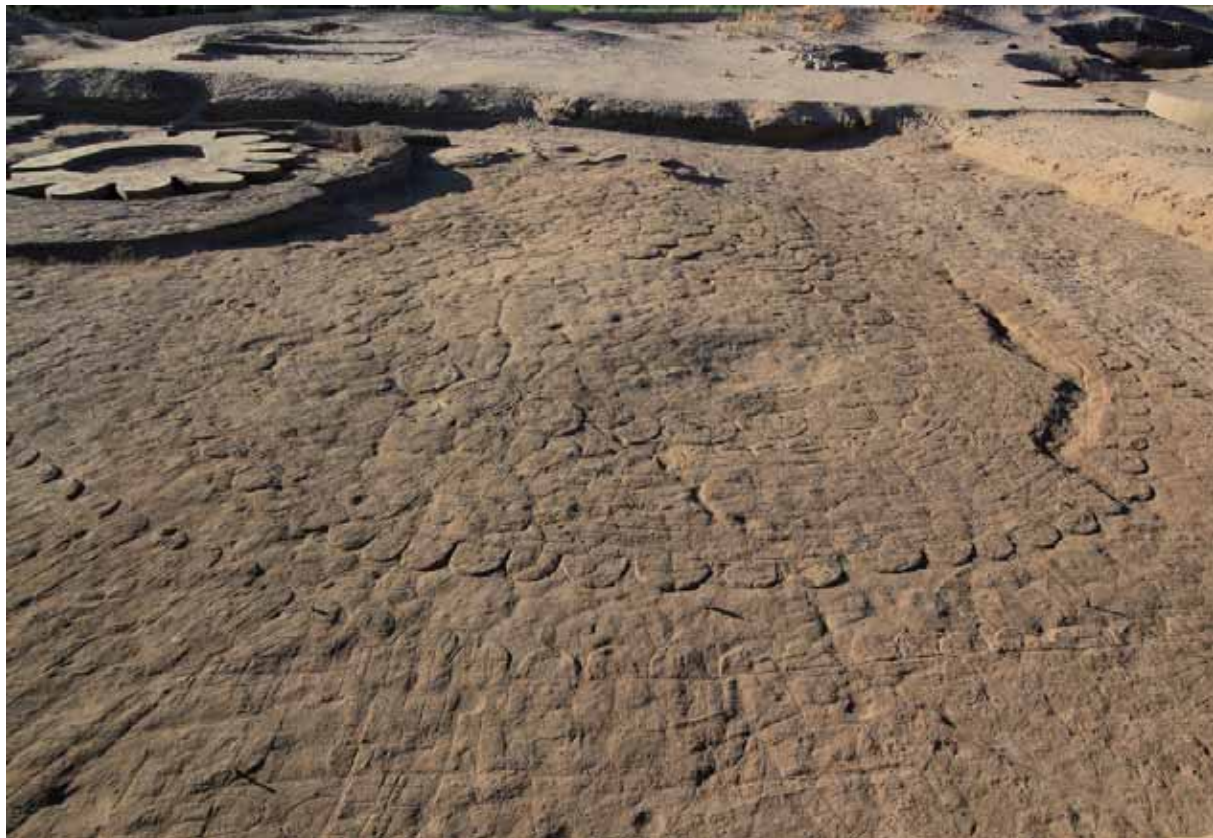
Figure 25 | General view of the ceremonial palace connected with the temples.

bearing seal imprints, in a wooden structure. It would therefore not be impossible that this circular edifice played a similar role, i.e. a ceremonial palace connected with the temple (fig. 25).
