# The archaeological site of Damboya in the Shendi Reach.

## Third season

Marc Maillot and Sébastien Poudroux

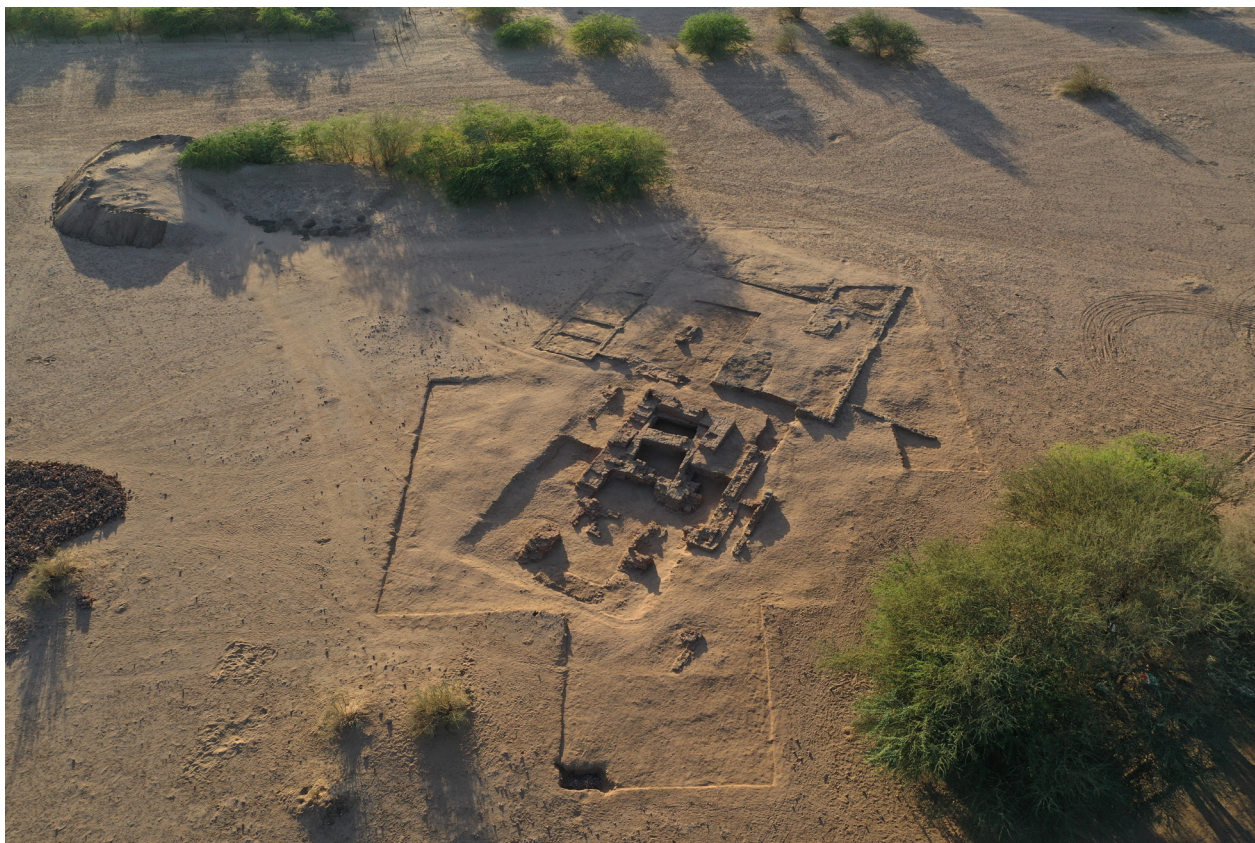
Figure 2. General view of Sector A, from the northeast. Cut of US 10 in the background (©SFDAS/musée du Louvre).

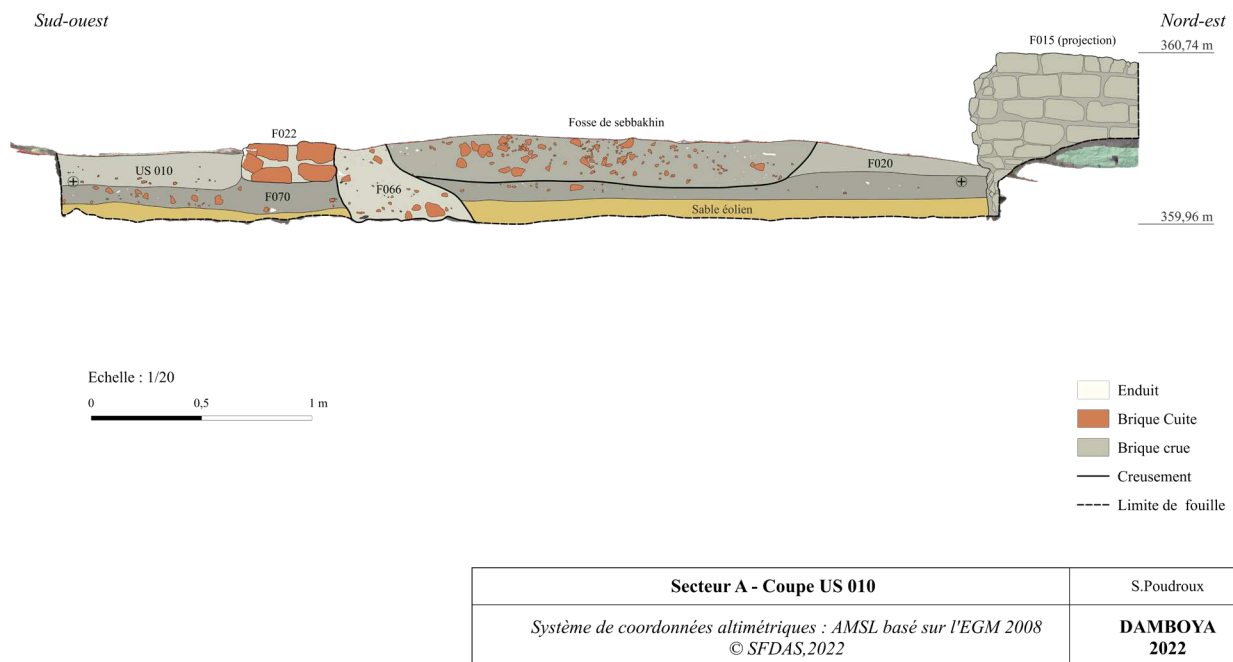
Figure 3. Cross section of US010/Wall F022 (©SFDAS/musée du Louvre).

A second sondage was opened at the junction between Wall F022 and US 10 to verify their relationship to one another (Figure 3). F022 has burnt bricks in its masonry and is connected to US 10 in the western

section of the wall. This area needed detailed clarification as explained previously (see Maillot 2021, 159), because a line of white plaster is contiguous with the foundation trench of Wall F022 and goes up against its exterior facing. The indurated clay floor (US 10) does not extend beyond Wall F022 to the north and is replaced by a standard floor of flattened raw earth, still present along Wall F015 (US 20). We can thus conclude that US 10 was designed to accommodate heavy traffic in an open area (the coating present along F022 towards US 10 confirms this). US 10 also covered a construction level (F70), composed of broken redbrick and fragments of grindstones. This level is the same as the construction floor of the temple (see Maillot 2021, F049, 160), as they share the same altitude and matrix (360.14m a.s.l.). This suggests that US 10 was laid after the construction of the temple corridor, making the whole junction between the temple and the western complex contemporaneous. The perfect alignment between F022, F007 and the entrance staircase F052 of the western complex seems to confirm the hypothesis.

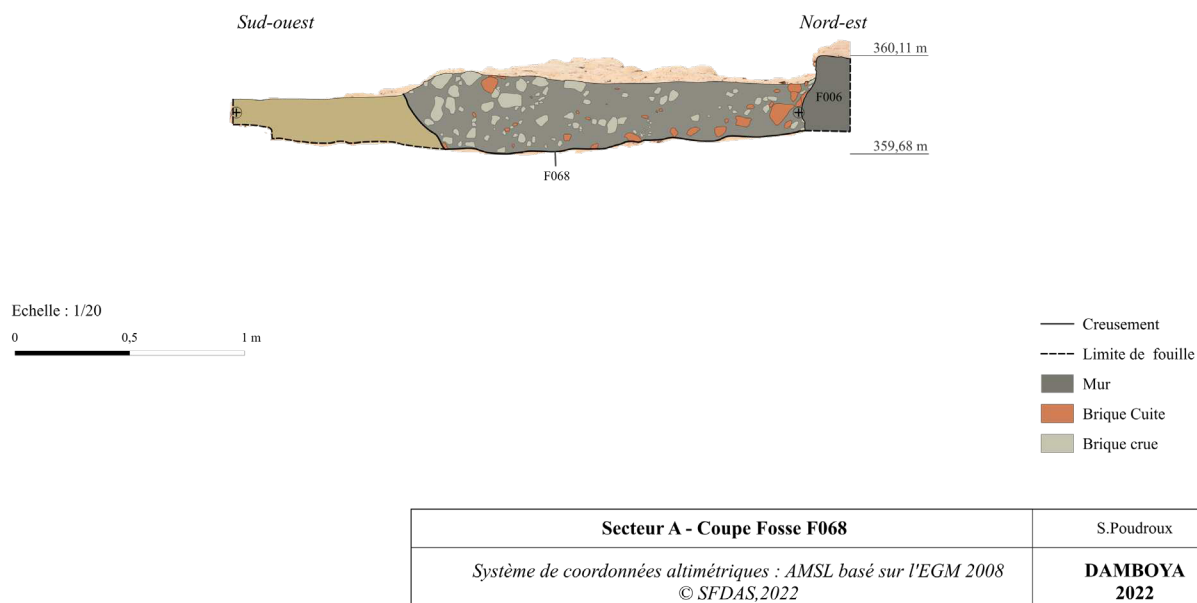
Figure 4. Cross section of F068 (©SFDAS/musée du Louvre).

must therefore have a returning wall that enclosed the corridor to the south at the intersection of the line of Wall F030 and Wall F050. The corridor had to frame the outer walls of the red brick temple for over two-thirds of its perimeter (13m), at the edge of partition Wall F028. Wall F030 and its southern counterpart were then joined respectively with the walls of the temple F007 and F006, unless a passage was created from the east, which we cannot verify due to the state of preservation of the building. Finally, and in the same way as for Wall F030, it is significant that a pit, full of mud brick destruction debris (F068, Figure 4), is visible to the west of this missing wall, which would imply a foundation method similar to F030, i.e. placed on an earlier destruction level (the double chamber 'chapel', see below), like Pit F044 (bottom alt. F030, 359.86m a.s.l.; bottom alt. of F068, 359.68m a.s.l., i.e. 180mm).

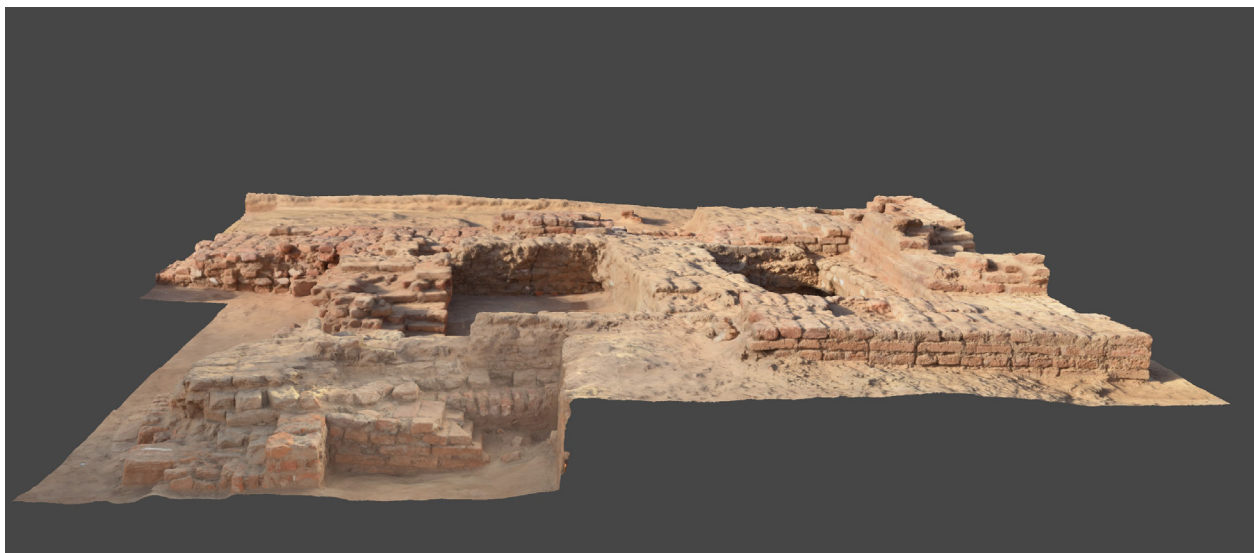
Figure 5. 3D model of the northern half of the chapel pylon and its reuse in the red brick temple (©SFDAS/musée du Louvre).

The angle formed by Walls F026 and F031 is the key to understanding this strange arrangement. Deeply founded (alt. min. 359.19m a.s.l.) with a fired brick on edge foundation course, this angle corresponds to the northern half of a pylon. Its symmetrical southern counterpart is attached to the section of the wall with mudbricks on edge, which was to serve as a support for a rectangular ferruginous sandstone threshold of similar dimensions (800 x 600mm). We are therefore in the presence of a double-chamber mudbrick chapel (3.88 x 7.02m at most, the external space is cut on all sides) with an entrance pylon in mudbrick faced with red bricks and access from east to west, identified thanks to a coated and painted threshold placed in the axis of the chapel. This axis is confirmed by mudbricks on edge appearing within Wall F018, exactly in line with this first threshold, opening onto the second west room of the chapel.

Season 2022 provided an opportunity to confirm the details needed to complete the description of the chapel pylon. The north half of the pylon was completely uncovered, allowing us to confirm that the construction method used was the same as that of the F026 wall of the redbrick temple. The builders reused the deep foundation of the chapel pylon to build the temple on stable ground. At the junction of F026 and F031, another section of Wall F007 was identified abutting the foundation of the chapel pylon by its masonry, which was laid in a herringbone pattern with thick mortar joints. We can also see from the *sebakhin* pit in Wall F007 that it was specifically targeted, probably because of its high concentration of redbrick. This enabled us to notice that the redbrick foundation on the edge of chapel Wall F031 (alt. 359.60m a.s.l.) was installed higher than the foundation of the pylon itself, and that the construction of the redbrick temple cut through half of the chapel wall thickness (Figure 5).

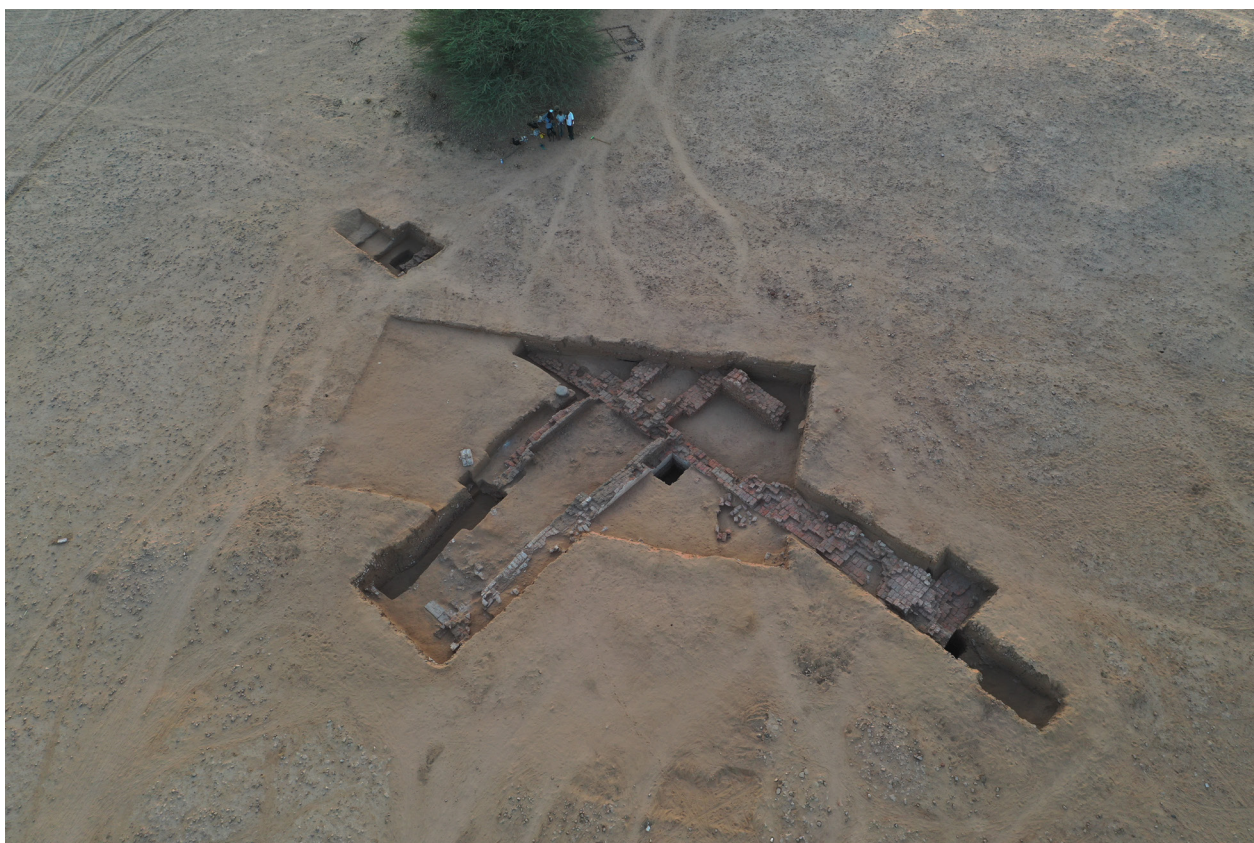
Figure 6. Sector G general view from northeast (©SFDAS/musée du Louvre).

The excavation of the central *kom* (Sector G) began during the first week, after the implementation of a 10x10m grid on the excavation area (two squares). This area was defined according to the east-west orientation of the complexes in Sectors A and E, with the hypothesis that a potential monumental building would follow the same axis. Two squares (330/530 and 330/540) were thus opened, and this hypothesis was confirmed very quickly (Figure 6).

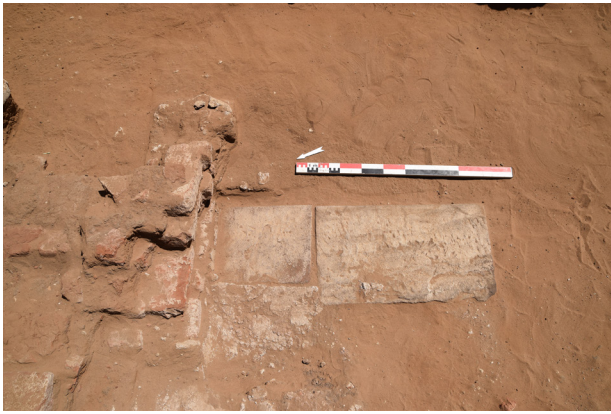
Figure 8. Threshold F61 of the monumental ramp (©SFDAS/musée du Louvre).

Similarly, a sondage was opened to the southeast in order to get the complete dimensions of the ramp, the partially preserved entrance of which is still marked by two slabs of ferruginous sandstone, indicating the presence of a threshold (F061, 800 x 400mm for the larger; 400 x 300mm for the other, Figure 8) and a reinforced angle (F065, a pedestal?). A polished fragment of an axe, a fragment of a lithic object and a metal object (iron point) were found at the angle of F065. This is most likely a foundation deposit. The south wall (F026) of the ramp was mostly destroyed by *sebakhin* pits down to its foundation. The whole formed a counterpart to pedestal F065 in the south, framing the access ramp.

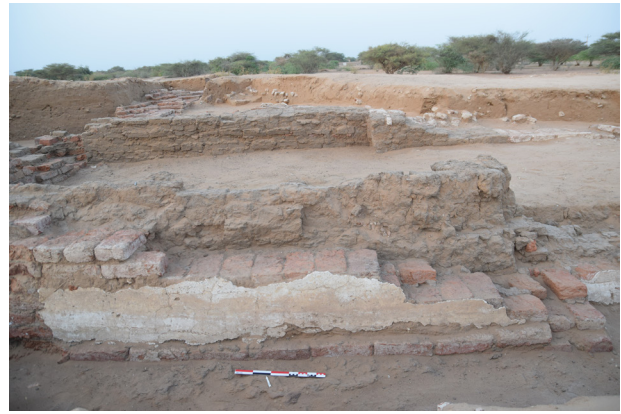
Figure 9. Ramp landing from south with its coating (©SFDAS/musée du Louvre).

The preserved part of the ramp consists of five courses of red bricks (350 x 180 x 80mm) laid in a header/stretcher pattern. According to the elevations, the slope of the ramp rises 860mm, compensating for an important height difference between the landing of the ramp and its eastern threshold (alt. min. 359.787m a.s.l., alt. max. 360.649m a.s.l.). This difference indicates a desire to elevate the building, probably to increase the majesty of its position at the centre of the site, especially when considering the building's decorative features. Wall F26 is made of mudbricks and its external facing is covered with painted plaster (Figure 9). A white sandstone statue of a lion (F011, Figure 10) was found nearby during the surface cleaning (US 30). Although not *in situ*, we can associate it with the ramp, and also with a fragment of a lion's paw in white sandstone, probably coming from another similar statue (destroyed or yet to be discovered), found during surface cleaning (US 30) in Square 330/540, north of Wall F023 of the ramp. The walls (F005 and F023) of the ramp landing are covered with painted plaster on their external facing and abut the front Wall F009.

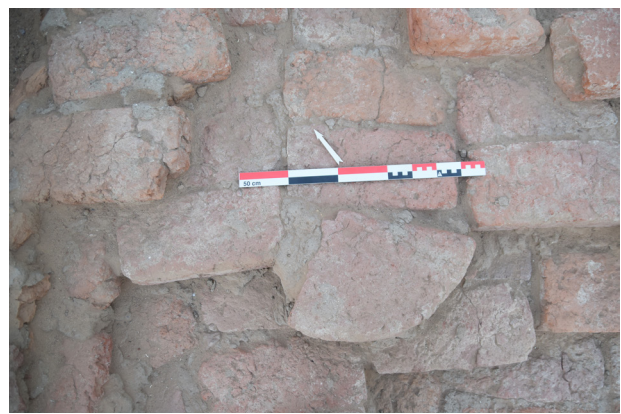
Figure 11. Quarter column brick reused in Wall F009 (©SFDAS/musée du Louvre).

A 1.5-metre-deep sondage was dug at the intersection of Walls F023 and F009 to establish their foundation level. Wall F09 has a combination of fired and mudbricks laid in a header/stretcher pattern. The utilisation of quarter-column bricks in the masonry indicates the presence of an earlier construction of importance (Figure 11). Its outer facing is also covered with painted plaster. As mentioned earlier, its width varies between 0.80m (south) and 2m (north). This difference may be explained by natural phenomena (more fragile ground to the north at the foundation level) or perhaps to repairs into the masonry (as could be attested by two circular red brick arrangements, appearing on the abandonment level of the wall, positioned at the angle of F020 and F009

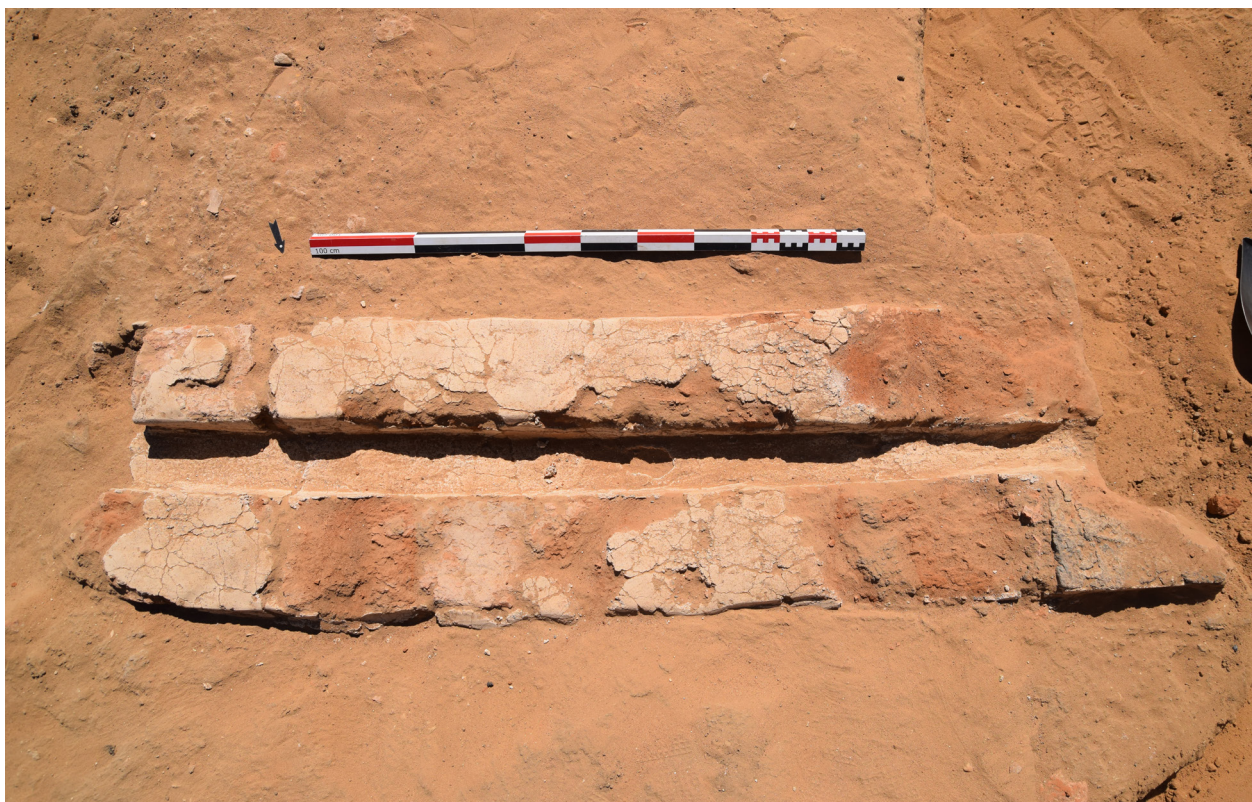
Figure 12. Water pipe F020 (©SFDAS/musée du Louvre).

A circular structure (F025) was partially excavated in the north-west corner of Square 330/540. Preserved on two layers of red bricks, its function remains unclear for the moment. A construction level is associated with it (US 75), unfortunately cut by Trench F013. Associated with floor Level F002, a waterpipe (F020), preserved over a length of 2m and a width of 0.50m, seems to have been embedded in the façade Wall F009 (Figure 12). It probably continues beyond the wall, as shown by the presence of an alignment of bricks (F087) following the same orientation, to the east of façade Wall F009.
